# BALLINAHOWN **Community Hall**

***Conservation Report in support of S.57 Application  
Regarding roof works at Ballinahown Community Hall***

***August 2024***

***Ballinahown Community Development Co. Ltd.***

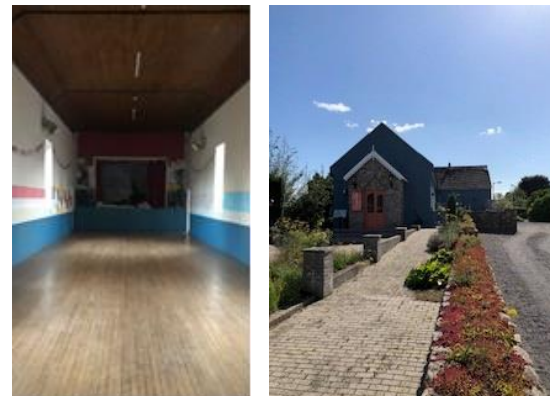
To this end any intended new works to the hall need to be assessed against the established character of the protected structure, and understanding reached as to the influence/effect of the proposed works on that character. The intended works described within this submission constitute the replacement of the roof finish to address ongoing leaks which have become manifest over the past few years within the Hall. It is submitted below that the intended works would constitute a positive effect on the protected structure and would in no way diminish the character which renders it a protected structure. The current artificial slates are c. 75 years old, are brittle, nail fixings have deteriorated, and the bitumen felt below is in poor condition.

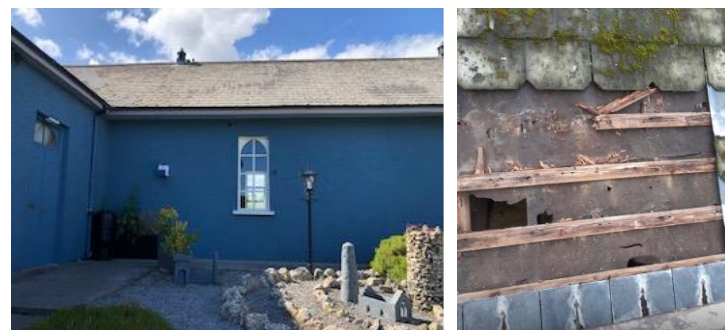
The Community Hall was originally constructed as a former Roman Catholic chapel based on a T-shaped plan, of c.1810. Its previous NIAH listing (Ref 15403510), (the hall is now delisted), records that it comprises a two-bay nave to the north, and single-bay transepts to the east and the west, retaining and reflecting still the early T-plan form and early proportions which contribute greatly to its current character. The building has been extensively used over the years and has lost some of its early fabric and historic character through various interventions. These have included a variety of new windows to the existing openings within the hall area, the construction of a rear extension lower in scale and volume to the main structure, internal upgrades to toilets, kitchen, studio spaces and services, disabled access to the front entrance and a roof covering consisting of asbestos cement slates fashioned with a chamfered shape. The style and weathering of the roof covering and felt as existent, would appear to suggest a date from c. 1950. This Section 57 Application of which this report forms a part, is focused on addressing the replacement of this existing roof covering and felt, with repairs to roof timbers only as necessary. The limited opening up which has occurred to address the current leaks reflects a very brittle bitumen felt, loose slates with rusted fixing nails and the self-evident existence of internal water penetration. It is these defects that the new slated finish is intended to address, combined with the visual benefit of returning the roof finish to a natural slate.

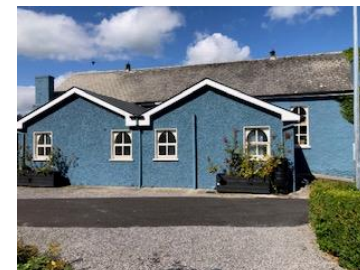
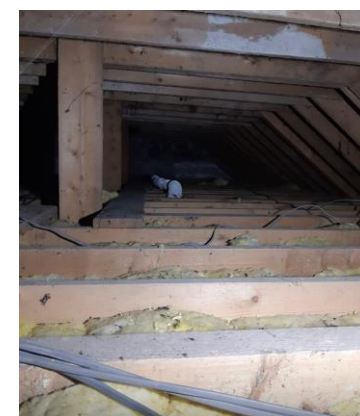
It is intended that a review of the energy performance of the Community Hall will be executed across 2025 under 'Just-transition Funding' which will require assessment of the hall's associated fabric and services. This will include the roofing of the south facing transept pitched roof (photo adjacent) which will accommodate either PV panels or PV integrated slates subject to investigation of these alternatives. All of these additional works will be part of a separate Section 57 application to be made to the Local Planning Authority later in the year.
