## IDT Report

**Re: CCTV Camera Survey & Drain Trace Results**  
**Engineer: Martin Murray Architects**  
**Property: St. Colmcille's Church & Parochial House, Ballinahown, Co. Westmeath**

**Re:** CCTV Camera Survey  
**Engineer:** Martin Murray Architects  
**Property:** St. Colmcille's Church, Ballinahown, Co. Westmeath

**Re:** CCTV Camera Survey  
**Engineer:** Martin Murray Architects  
**Property:** Parochial House, Ballinahown, Co. Westmeath

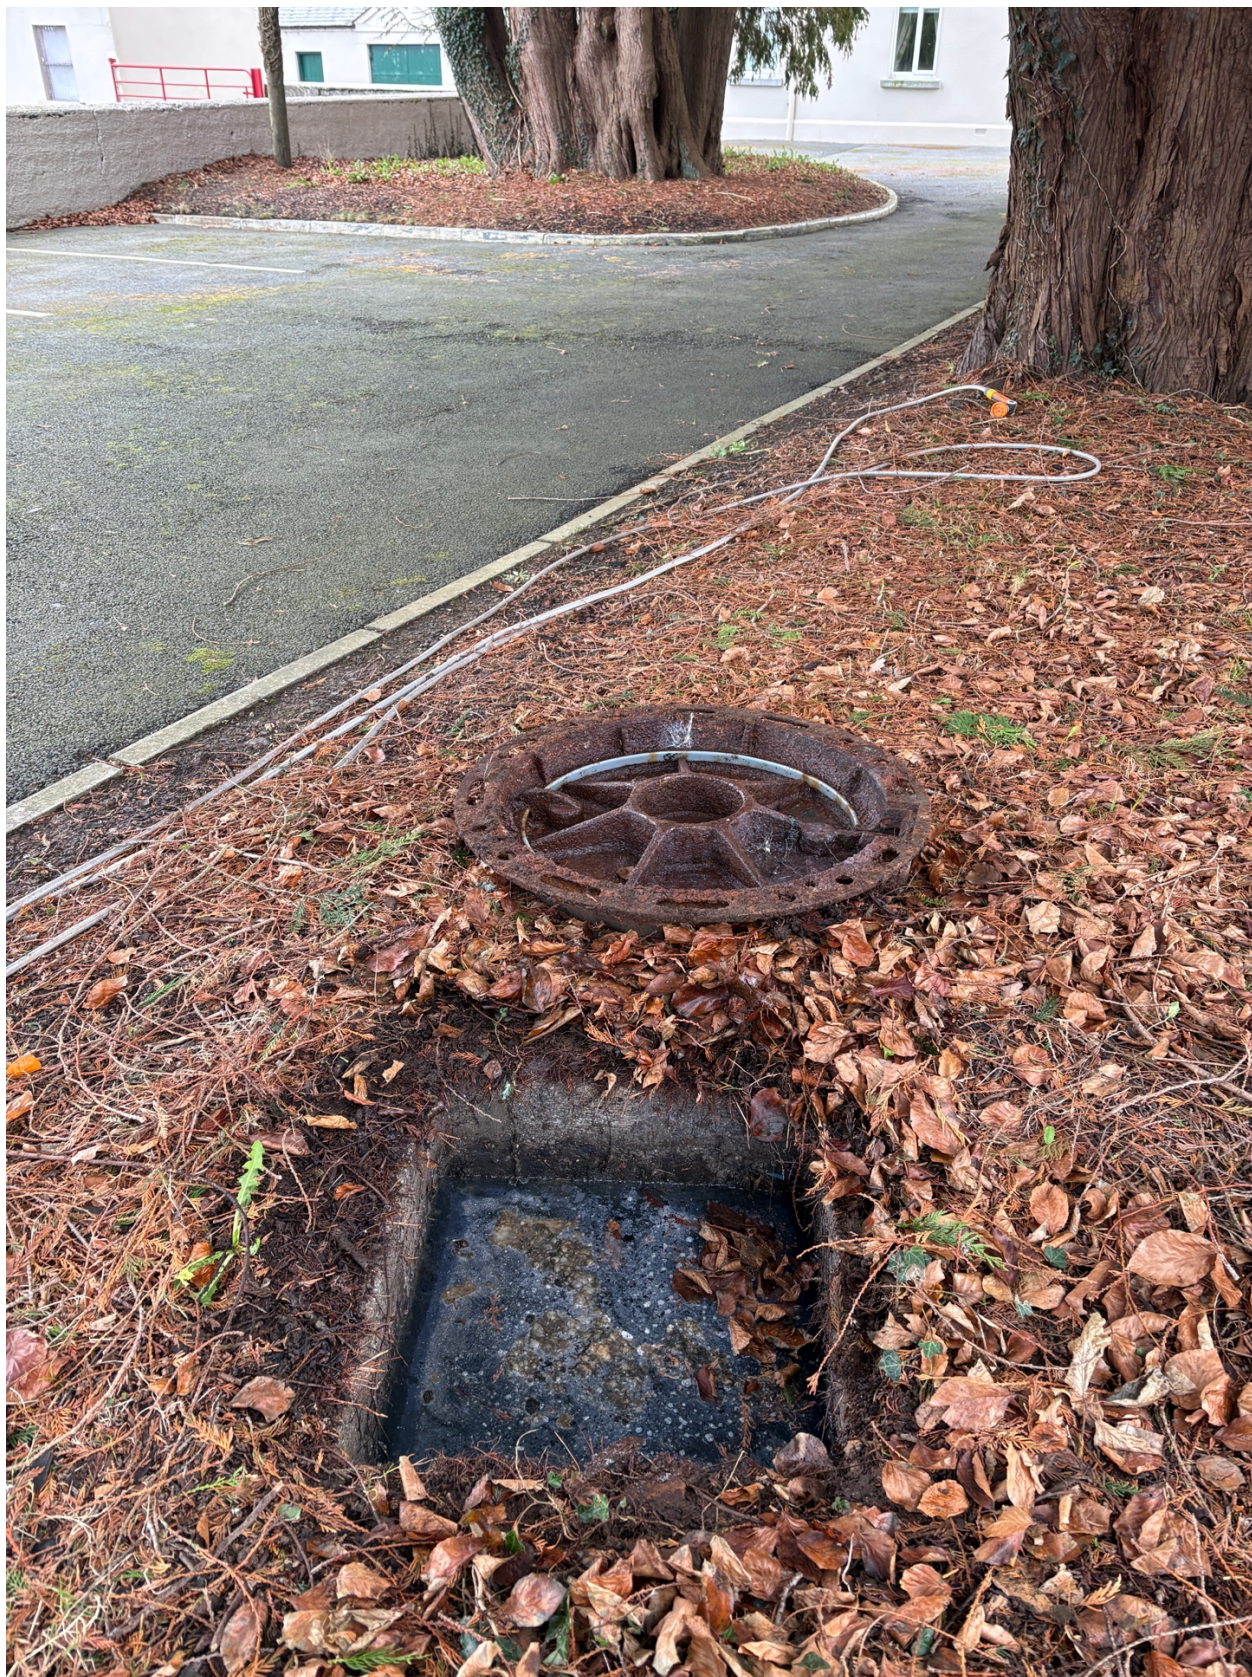
The manhole was also **full** of water and subsequently emptied.

The manhole.

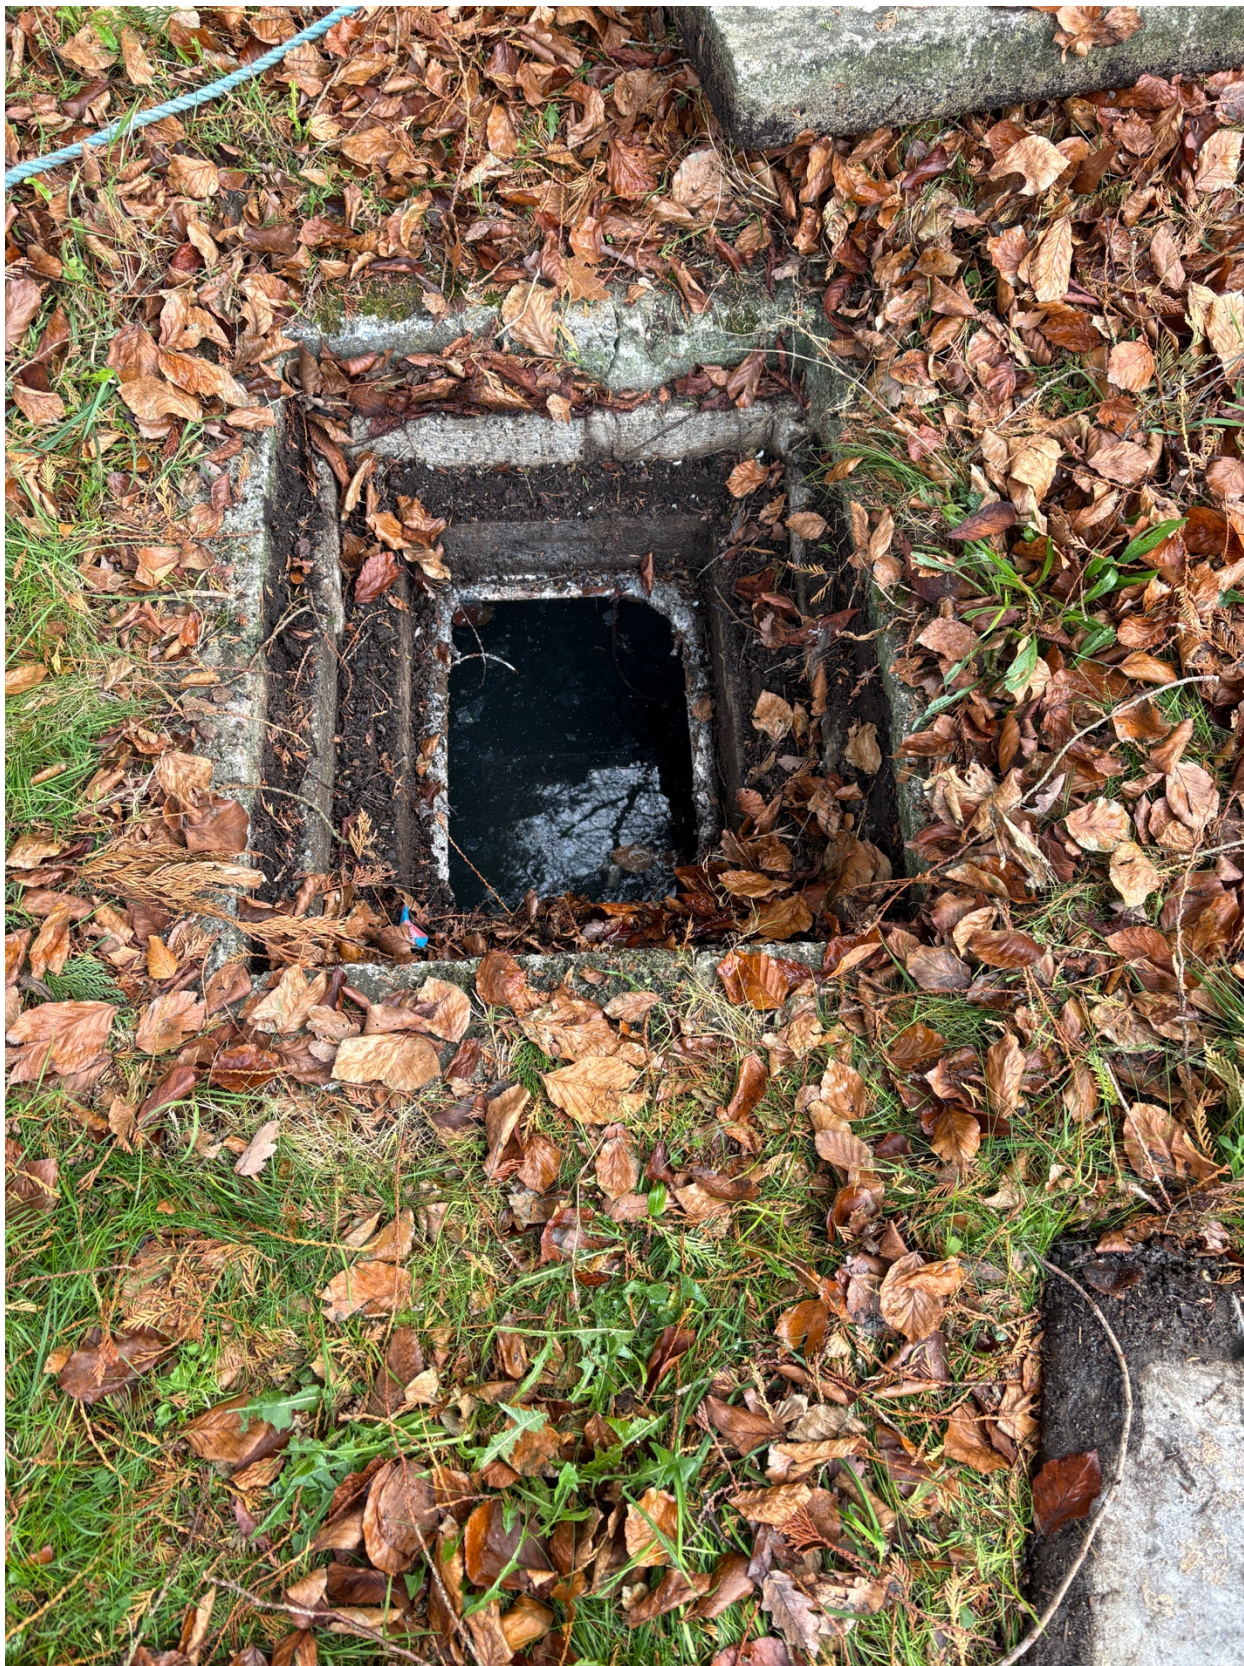
The septic tank was **full** on arrival and subsequently emptied.

The septic tank.

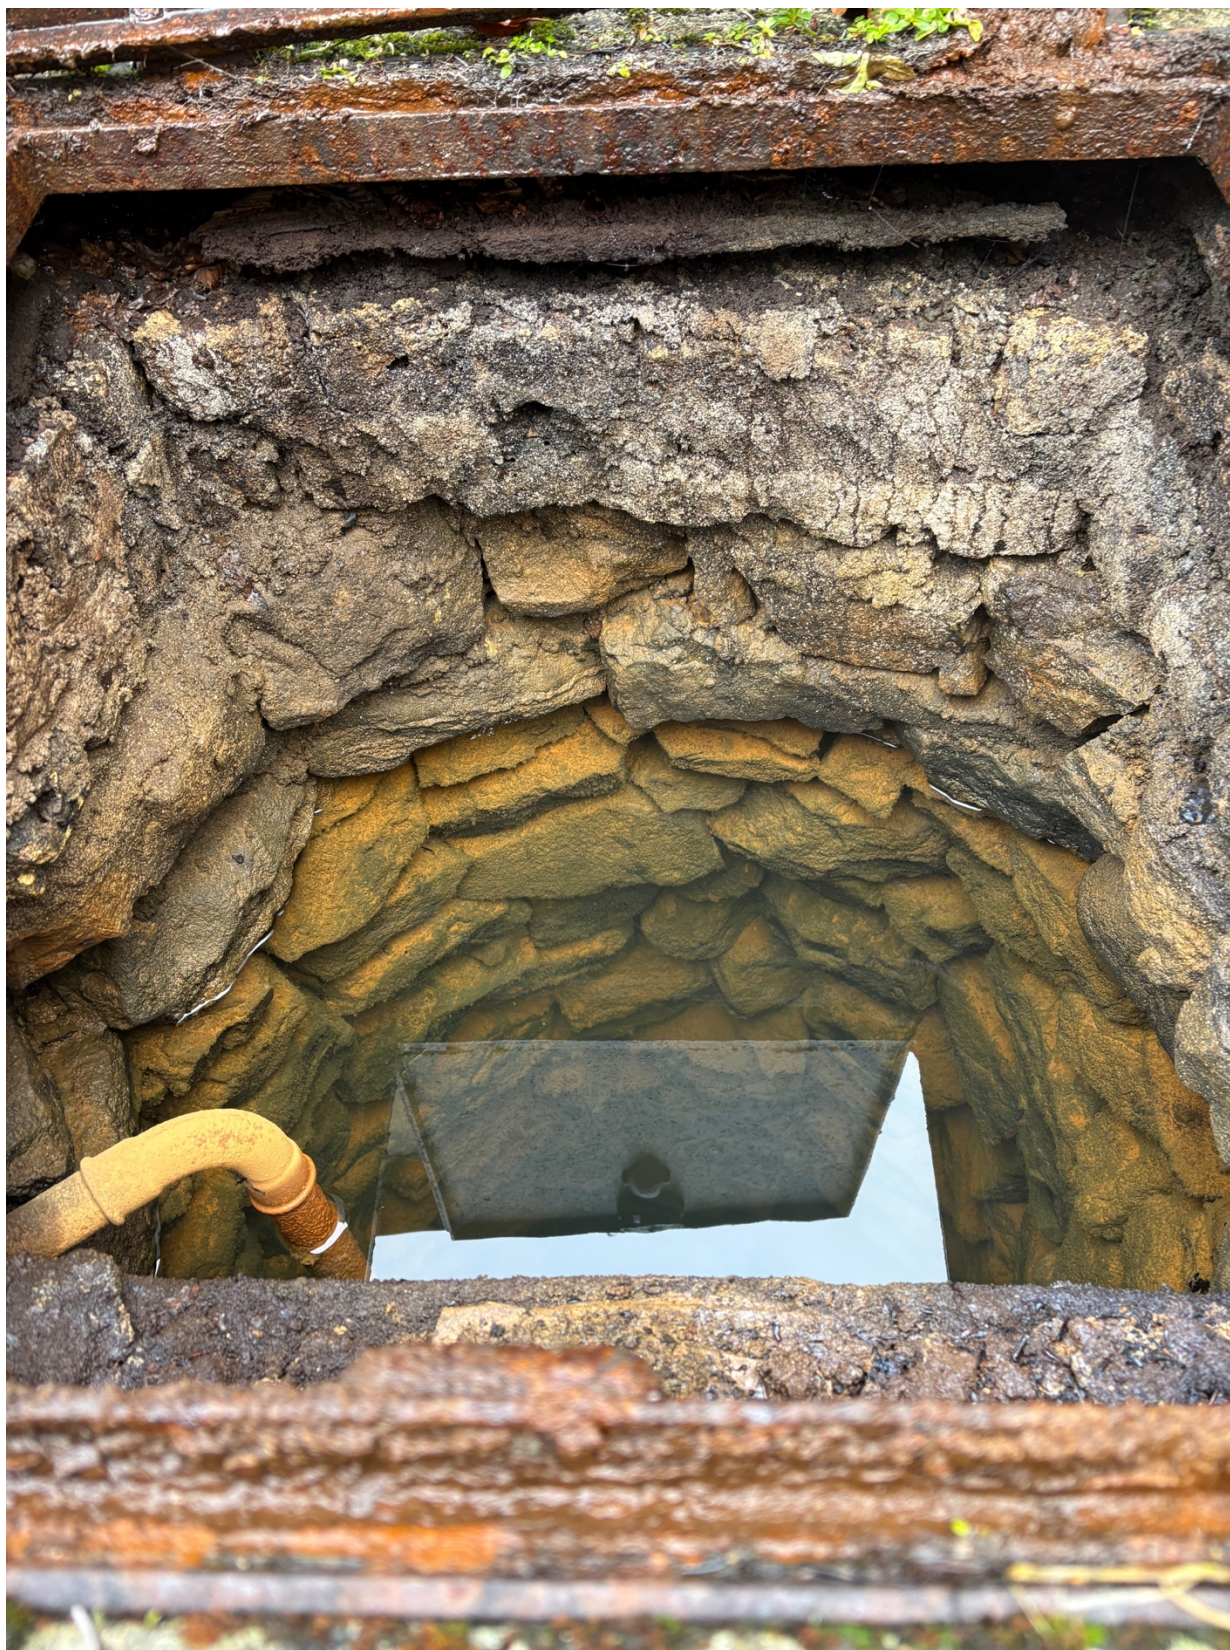
The well.

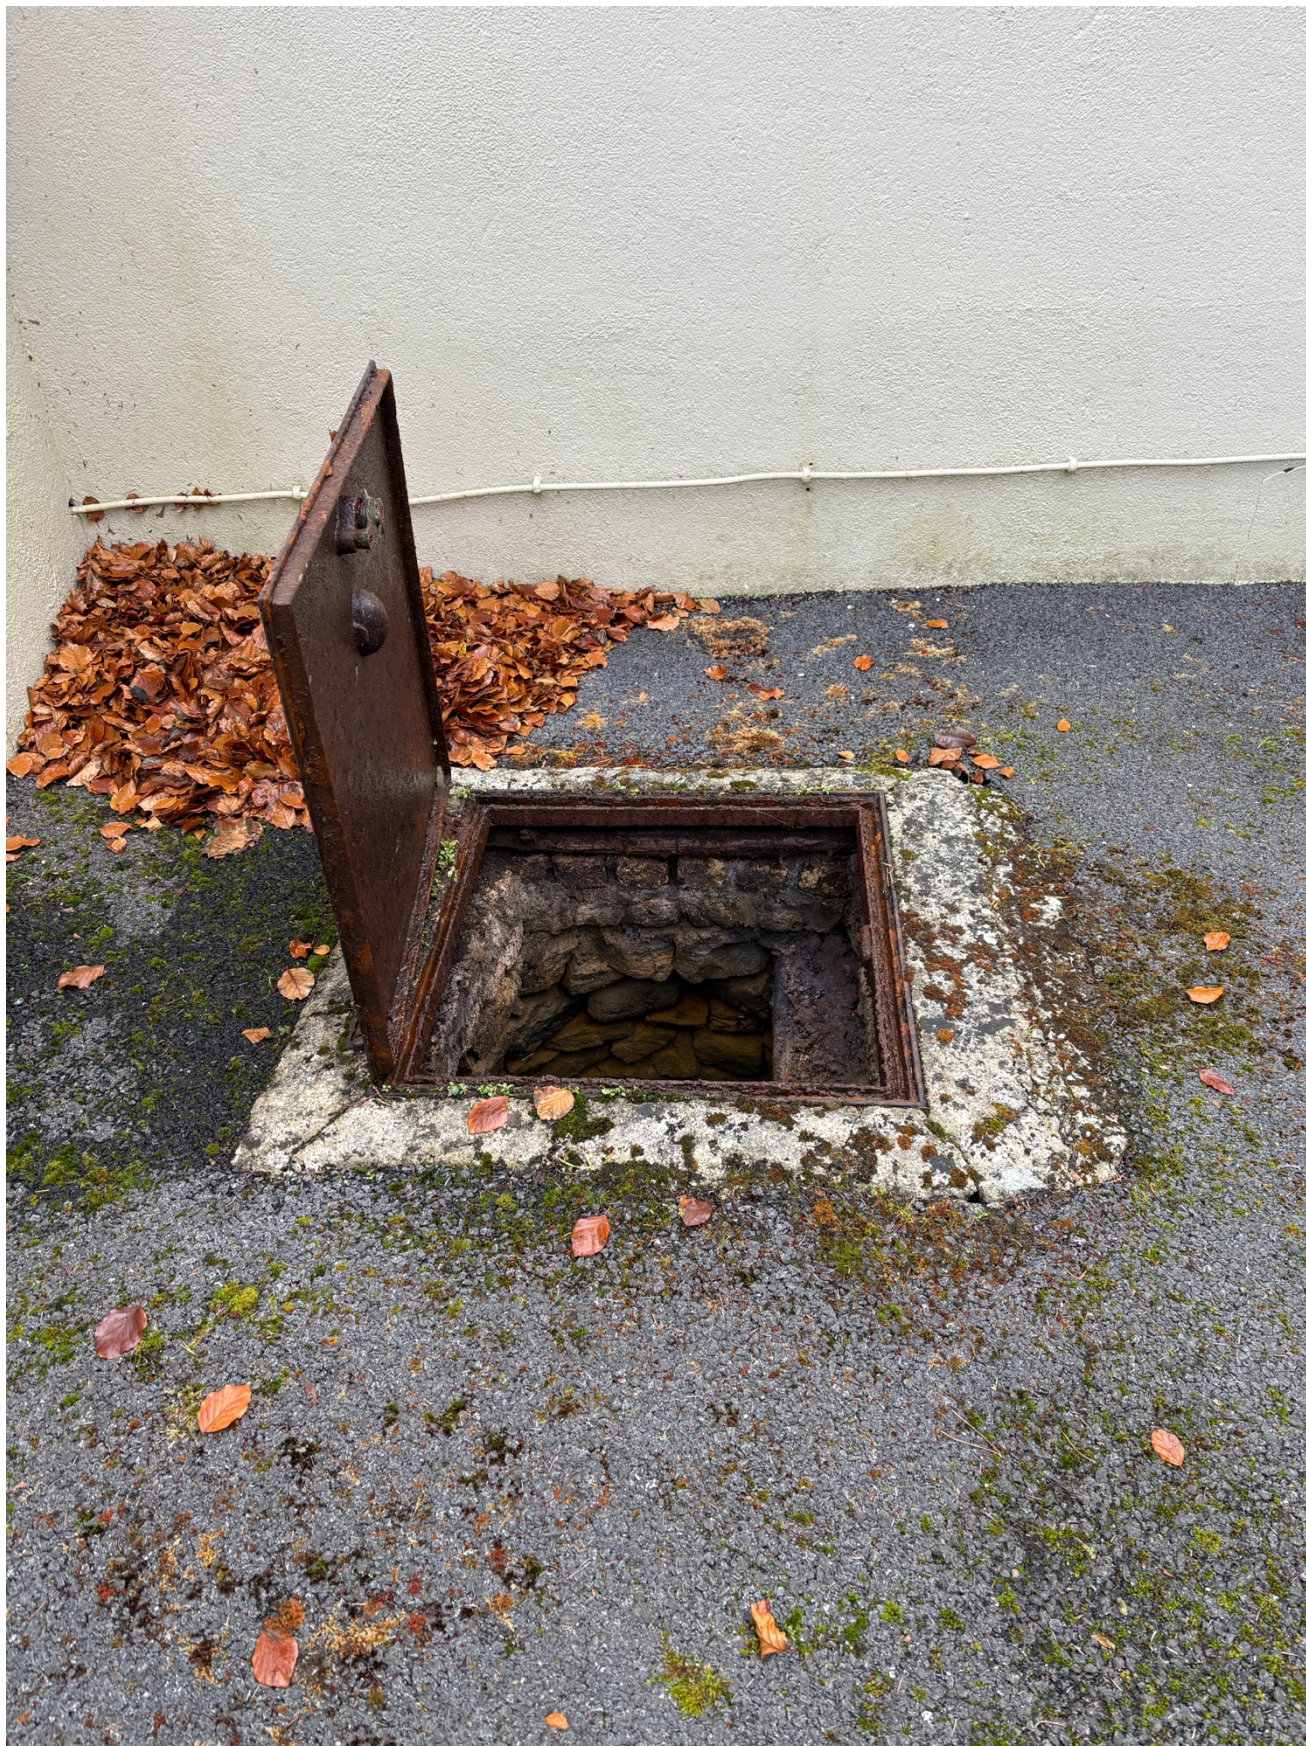
The well cover.

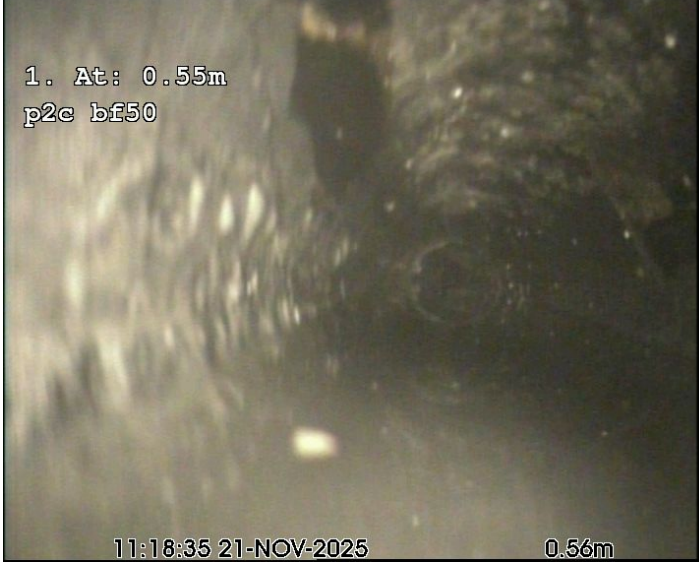
| <p>1. At: 0.55m<br/>p2c bf50</p> <p>11:18:35 21-NOV-2025 0.56m</p> | <p>1. At: 0.55m<br/>a pvc pipe connects to a clay pipe<br/>a backfall in the pipe is visible:<br/>the water level is at 50% of the diameter of the pipe.</p> |

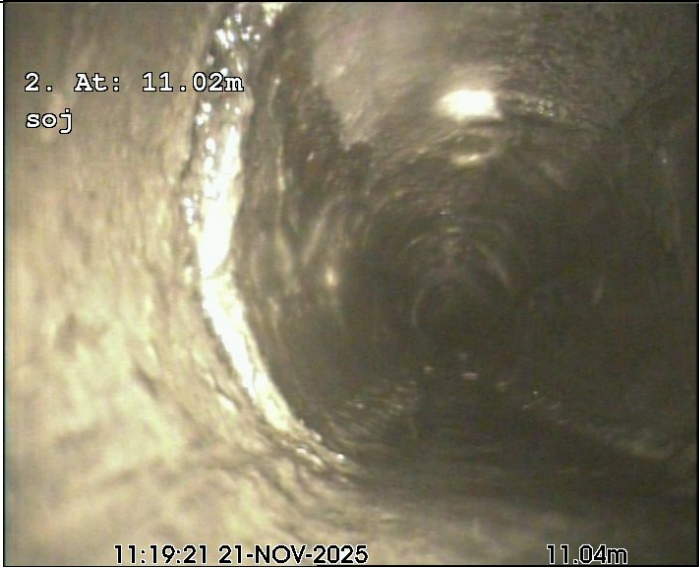
| <p>2. At: 11.02m<br/>soj</p> <p>11:19:21 21-NOV-2025 11.04m</p> | <p>2. At: 11.02m<br/>A slightly open joint is visible.</p> |

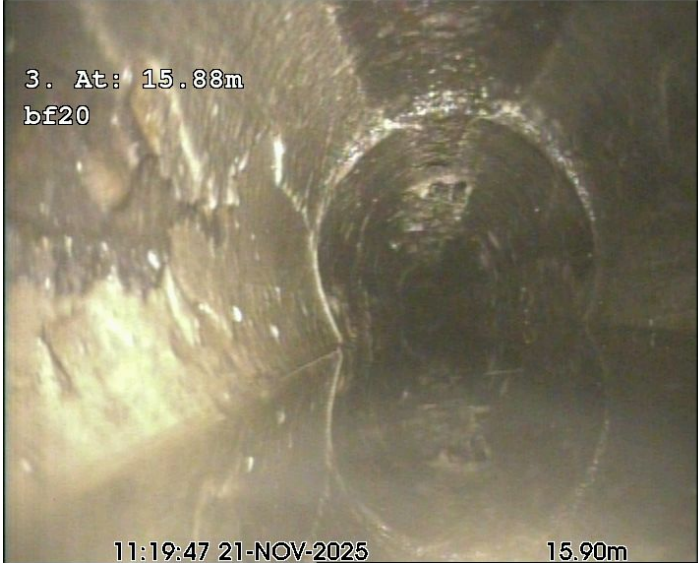
| <p>3. At: 15.88m<br/>bf20</p> <p>11:19:47 21-NOV-2025 15.90m</p> | <p>3. At: 15.88m<br/>a backfall in the pipe is visible:<br/>the water level is at 20% of the<br/>diameter of the pipe.</p> |

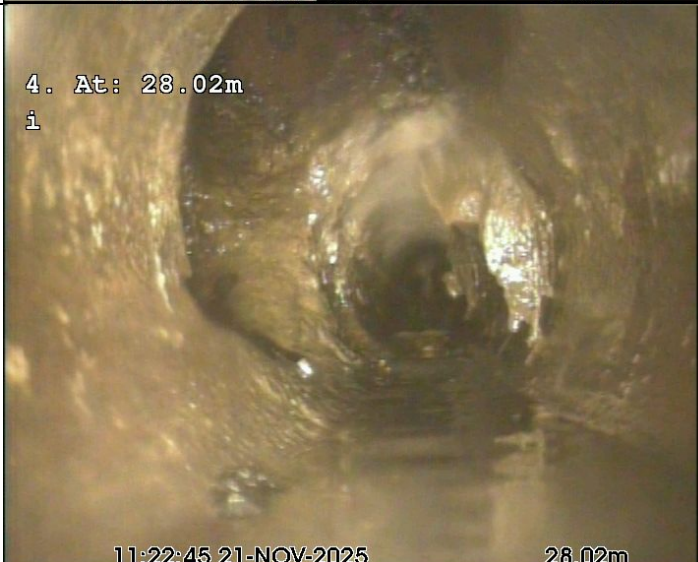
| <p>4. At: 28.02m<br/>i</p> <p>11:22:45 21-NOV-2025 28.02m</p> | <p>4. At: 28.02m<br/>Inlet</p> |

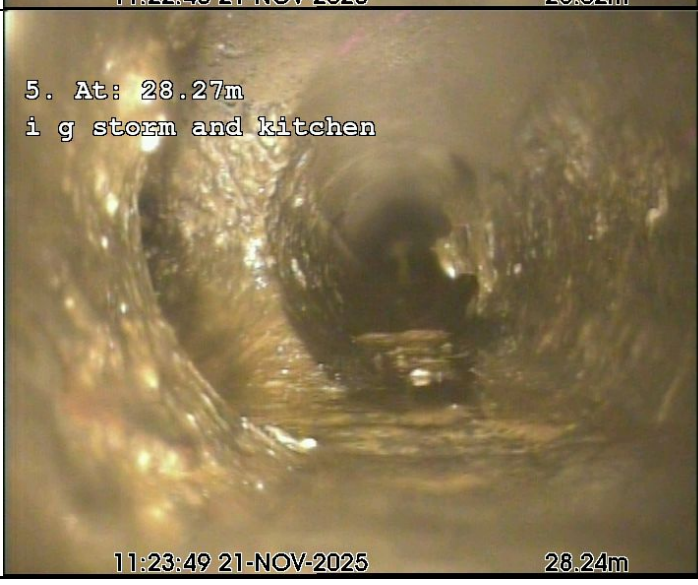
| <p>5. At: 28.27m<br/>i g storm and kitchen</p> <p>11:23:49 21-NOV-2025 28.24m</p> | <p>5. At: 28.27m<br/>Inlet from a gully taking storm<br/>and kitchen waste</p> |

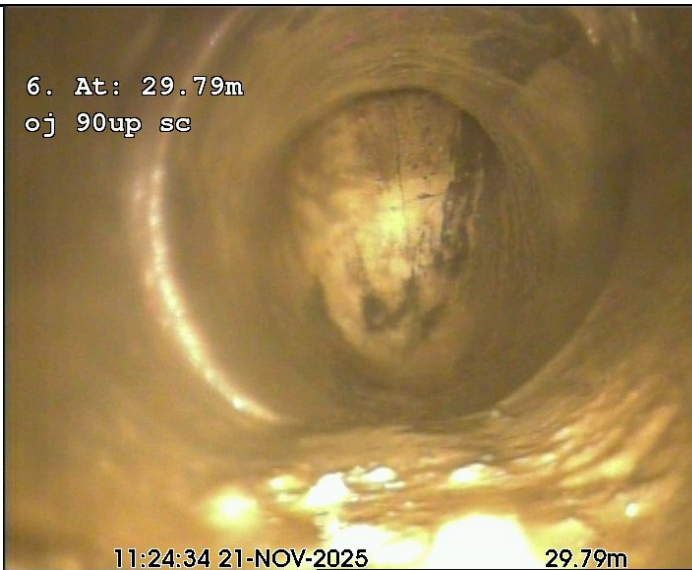
| <p>6. At: 29.79m<br/>oj 90up sc</p> <p>11:24:34 21-NOV-2025 29.79m</p> | <p>6. At: 29.79m<br/>An open joint is visible.<br/>a 90° bend upwards is visible.<br/>slight cracking in the pipe is visible</p> |

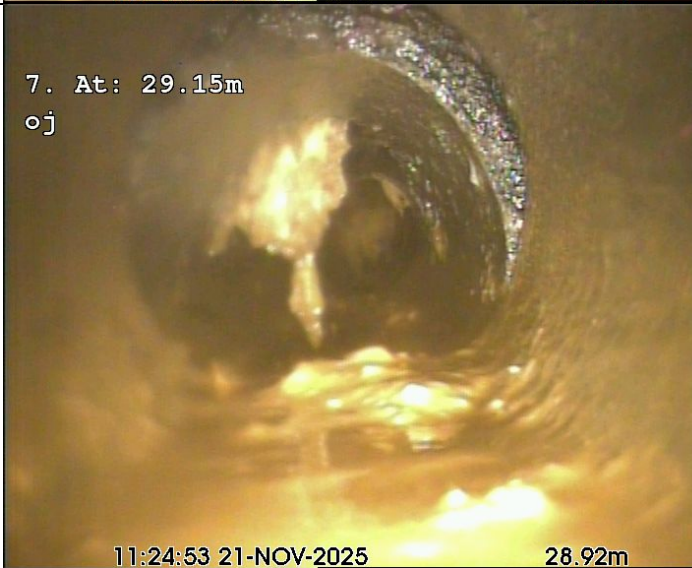
| <p>7. At: 29.15m<br/>oj</p> <p>11:24:53 21-NOV-2025 28.92m</p> | <p>7. At: 29.15m<br/>An open joint is visible.</p> |

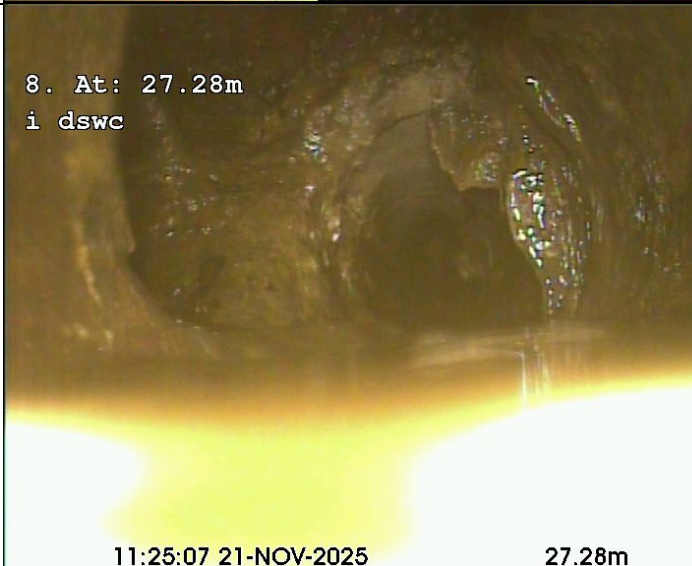
There is a **consistent flow of water** from the downstairs wc in the parochial house that is also filling up the septic tank.

| <p>8. At: 27.28m<br/>i dswc</p> <p>11:25:07 21-NOV-2025 27.28m</p> | <p>8. At: 27.28m<br/>Inlet from a downstairs wc</p> |

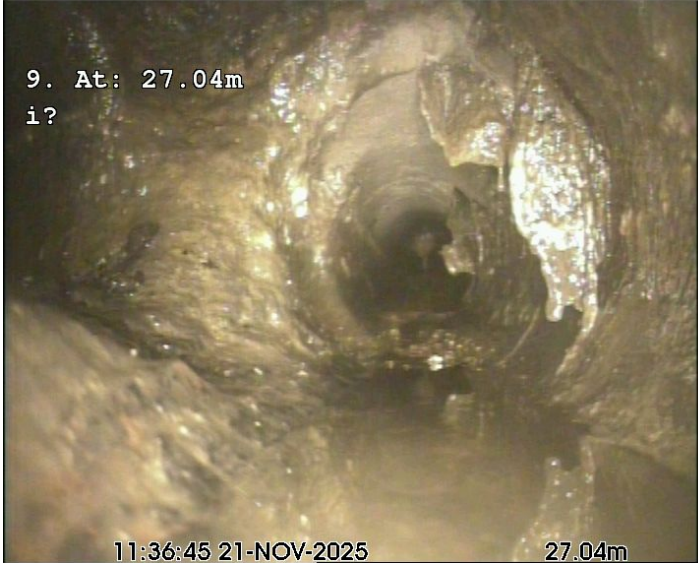
| <p>9. At: 27.04m<br/>i?</p> <p>11:36:45 21-NOV-2025 27.04m</p> | <p>9. At: 27.04m<br/>Unknown inlet</p> |

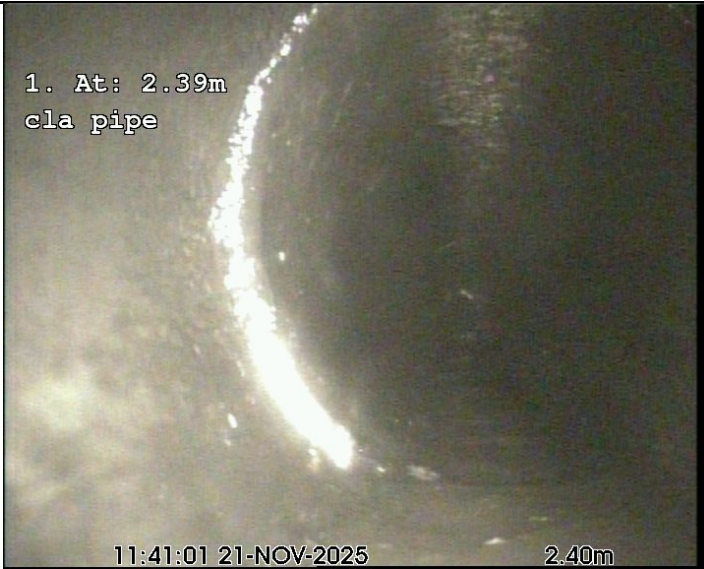
| | 1. At: 2.39m<br>Clay pipe |

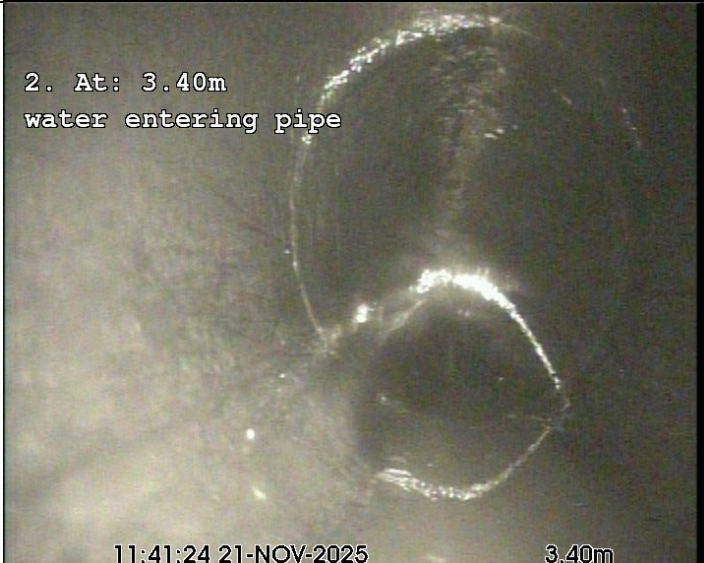
| | 2. At: 3.40m<br>water entering the pipe |

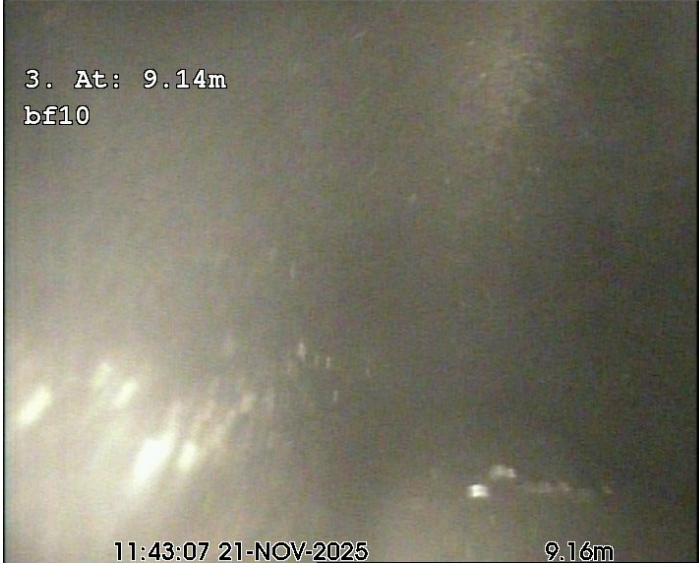
| <p>3. At: 9.14m<br/>bf10</p> <p>11:43:07 21-NOV-2025 9.16m</p> | <p>3. At: 9.14m<br/>a backfall in the pipe is visible:<br/>the water level is at 10% of the<br/>diameter of the pipe.</p> |

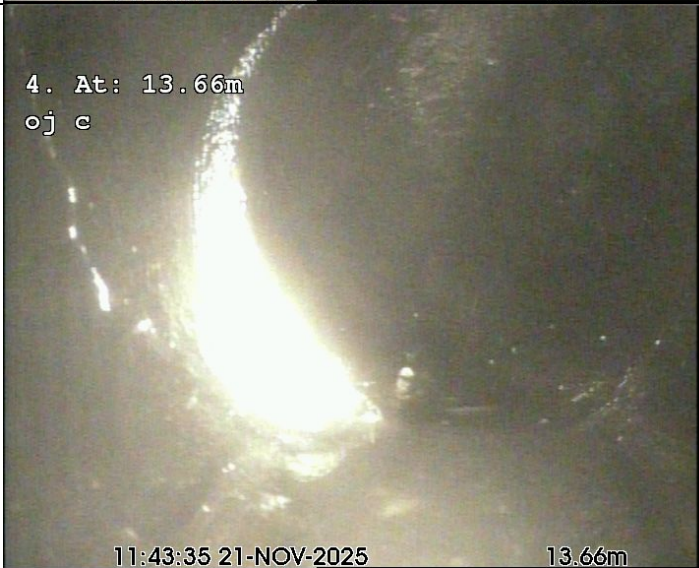
| <p>4. At: 13.66m<br/>oj c</p> <p>11:43:35 21-NOV-2025 13.66m</p> | <p>4. At: 13.66m<br/>An open joint is visible.<br/>Cracking in the pipe is visible.</p> |

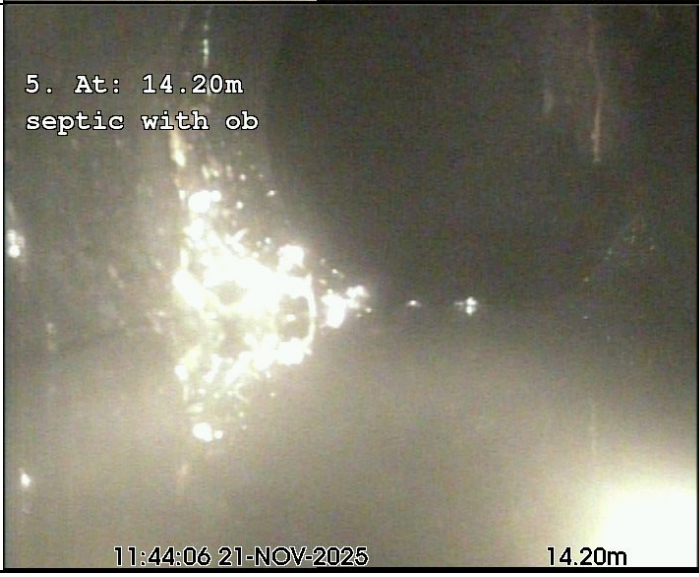
| <p>5. At: 14.20m<br/>septic with ob</p> <p>11:44:06 21-NOV-2025 14.20m</p> | <p>5. At: 14.20m<br/>Septic tank with an obstruction in<br/>the pipe.</p> |

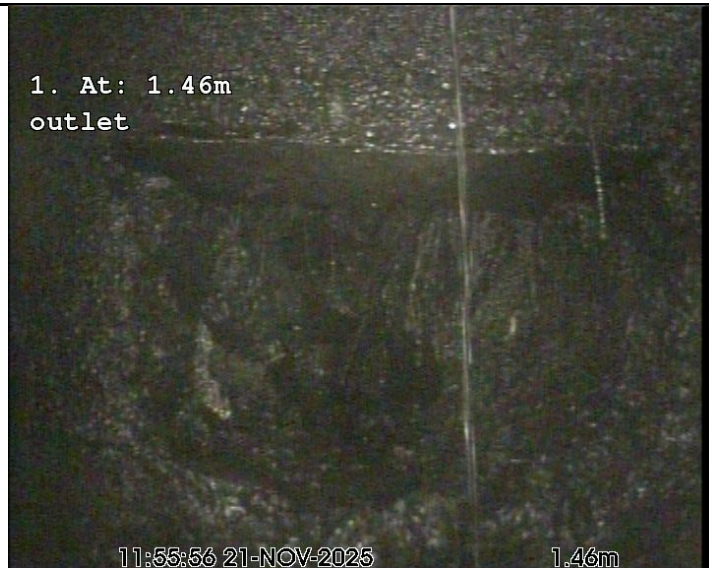
| | 1. At: 1.46m<br>outlet |
