# **CONSERVATION-BIODIVERSITY 10-YEAR STRATEGY PLAN** *for* ***St Colmcille's Church, Ballinahown, Co Westmeath***

**Martin Murray Architects**

# CONSERVATION-BIODIVERSITY 10-YEAR PLAN FOR ST COLMCILLE'S CHURCH, BALLINAHOWN.

(NIAH REG. 15403512, AND WCC RPS: 035-008),

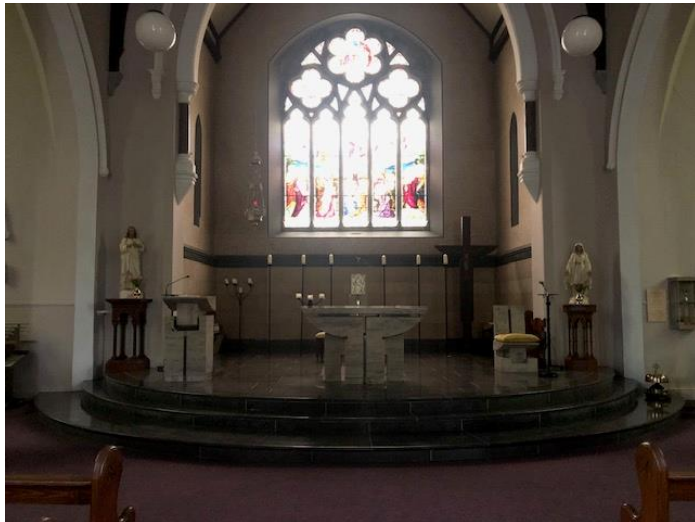
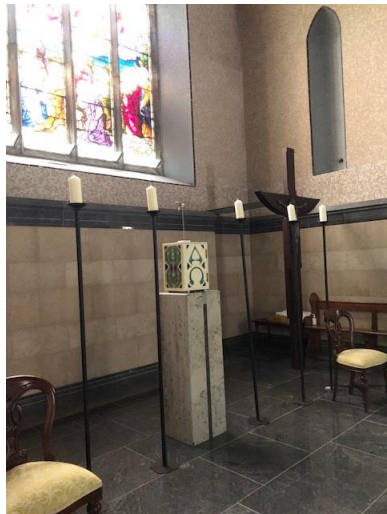
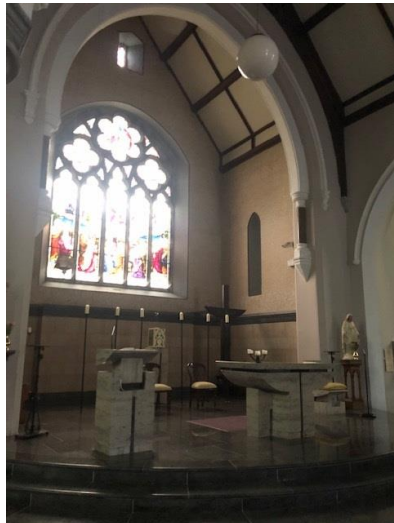
| 3.3 Clarity of Liturgical Space | The tabernacle lacks visual prominence and would benefit from a redesign to address both scale and lighting. The addition of a specific reredos might be adequate in itself to resolve the visual weakness. | | |

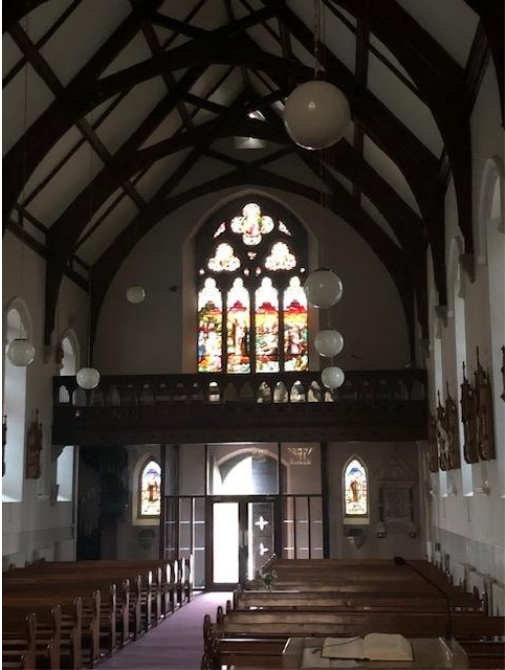
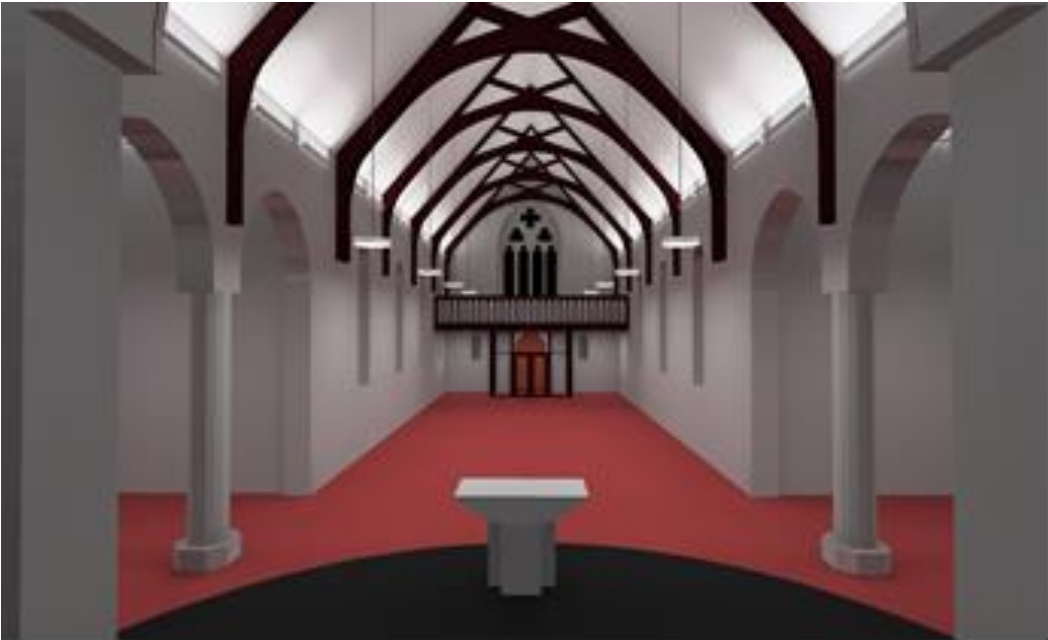
| <p><b>3.5 Lighting</b></p> | <p>A number of options were discussed in regard to the church lighting. Reusing existing connections would be the most economical solution and is the option indicated within the visual images.</p> |

The long-term costs reflect the rewiring of the Church, a decision in this regard could be made in 2026. External lighting could go hand in hand with landscape initiatives to improve biodiversity. The external lighting might focus on site circulation and on celebrating the architectural features of the church.

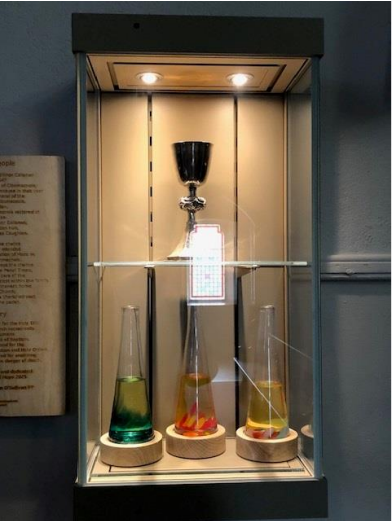
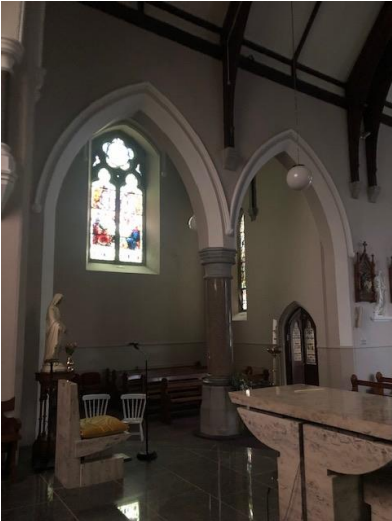
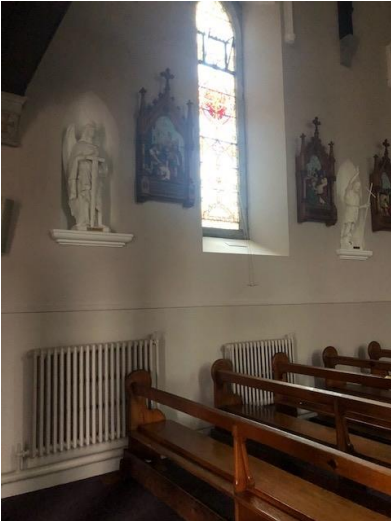
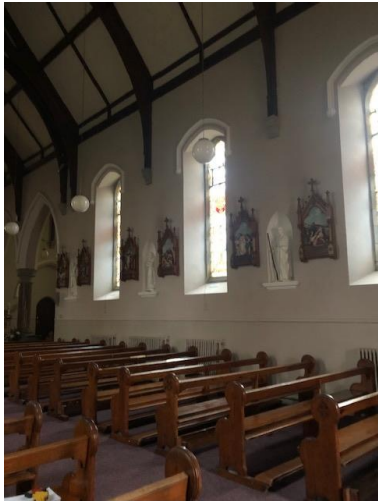
| 3.7 Decoration | There is significant detail within the church which would warrant careful development of a colour scheme in association with progressing the liturgical clarity of the space | | |

The decoration can go hand in hand with developing greater liturgical clarity and lightness within the overall space.

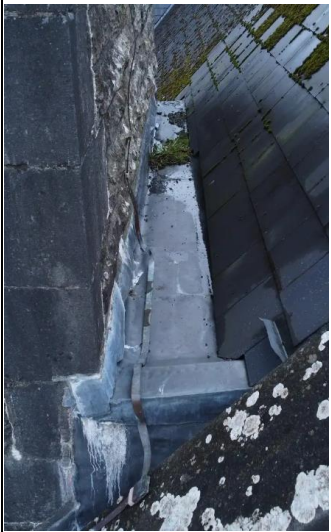
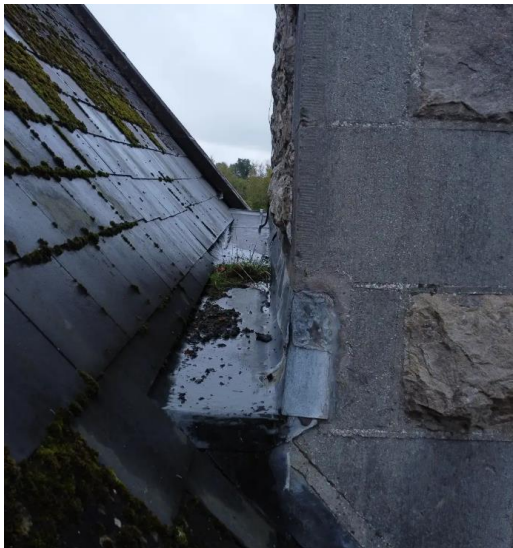
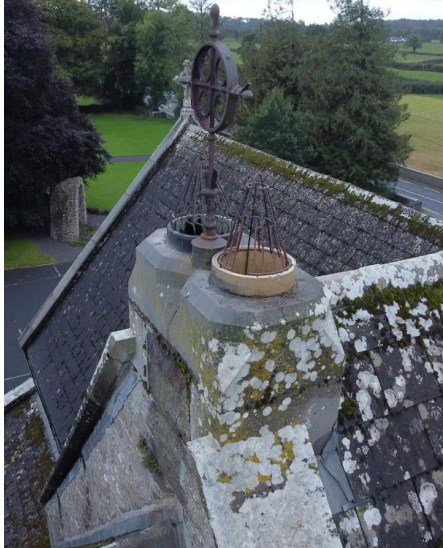
| 4.1 Gutter to rear of belfry tower. | The upper gutter and flashing are leaking; the photo-record of the gutter indicate that it is holding water and that the lap lacks evidential thickness to indicate a fold in the lead as would be good practice. Opening up needs to be performed internally in the first instance to establish the location of the water ingress, and its extent | | |

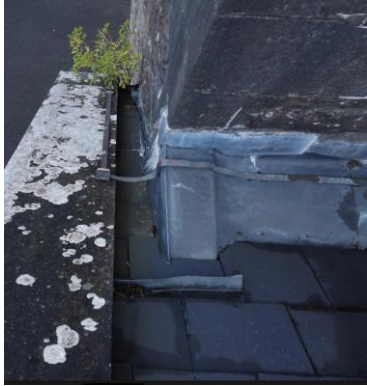
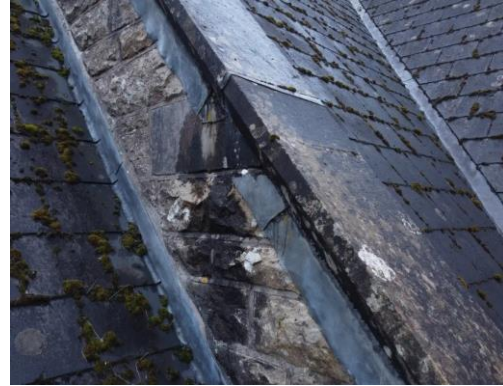
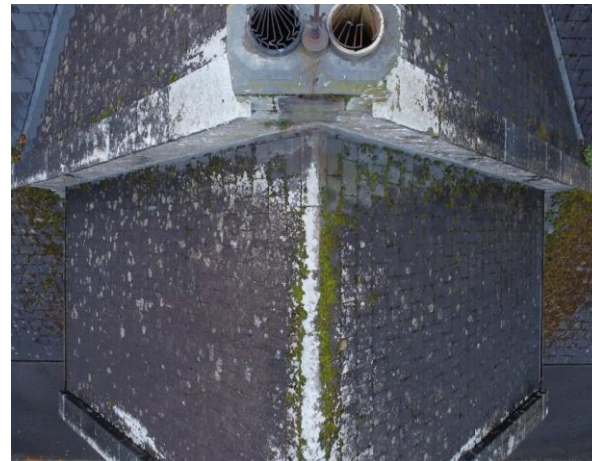
#### 4.2 Miscellaneous roof repairs (Including verges and parapets)

The church has an architectural expression of steeply raked stone parapets, typical of the design ethos at the time. These are prone to water penetration in the long term and will require phased inspection over the 10 year plan and localised repair. A lead capping to the parapets may be a long-term solution.

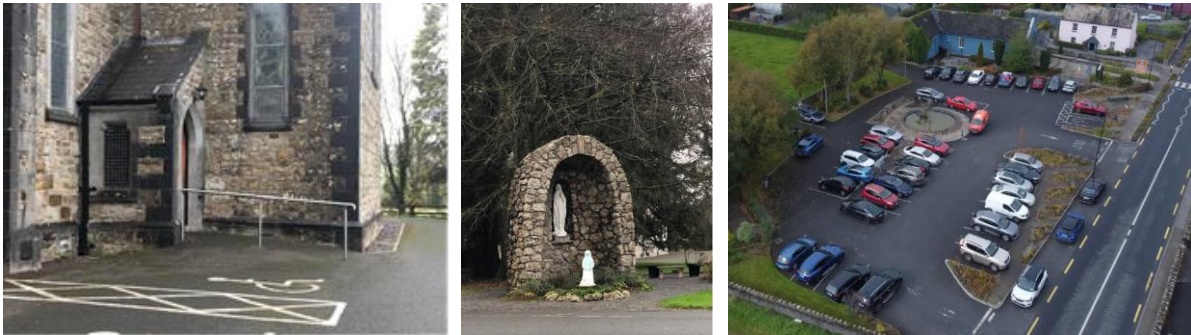
| 5.1 Existing carparking | The car parking is functional and lacks potential for biodiversity unless some alterations are carried out; existing disabled access ramps are not compliant with current regulations and might be considered for expenditure in medium term. | |

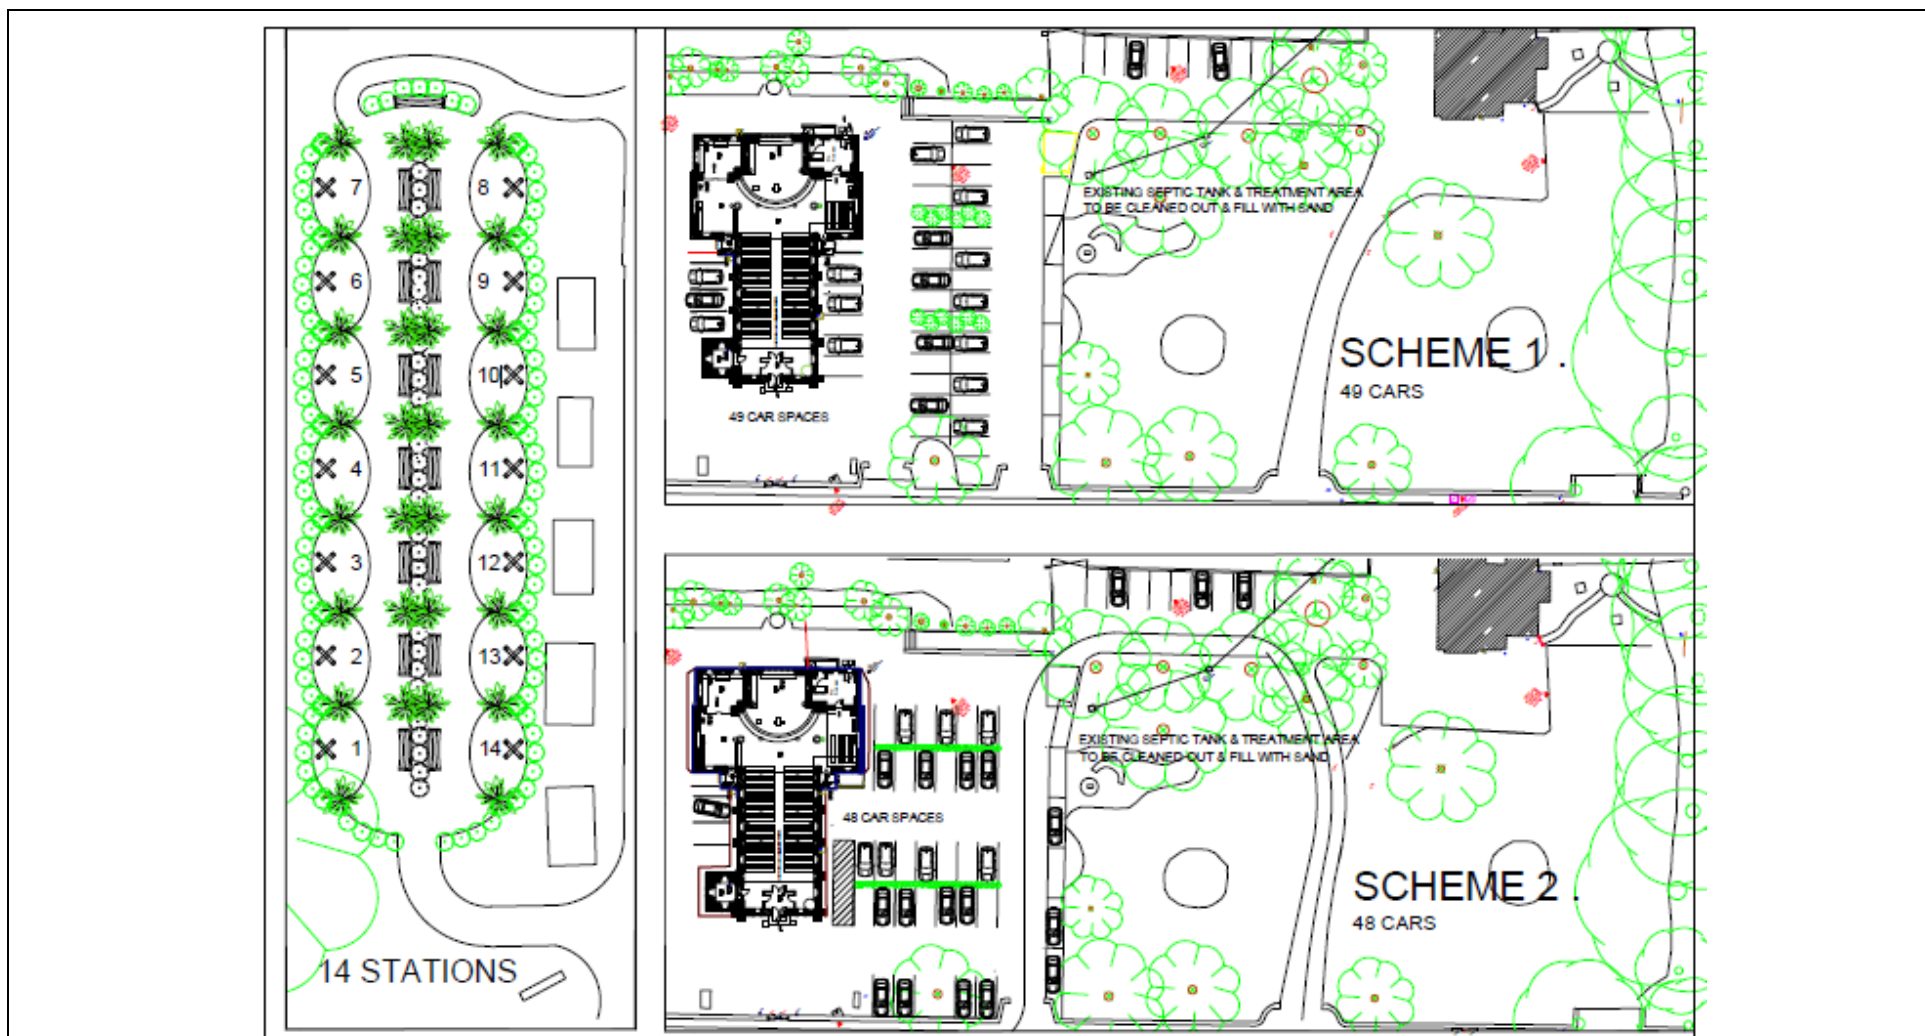
*Illustration 03:* From left to right (i) Proposed External area for reflection within the church grounds (set out as a stations of the Cross). Scheme 1: Parking alterations to existing layout to facilitate biodiversity or Scheme 2: Parking reflecting significant redesign in layout, (may be unwarranted).

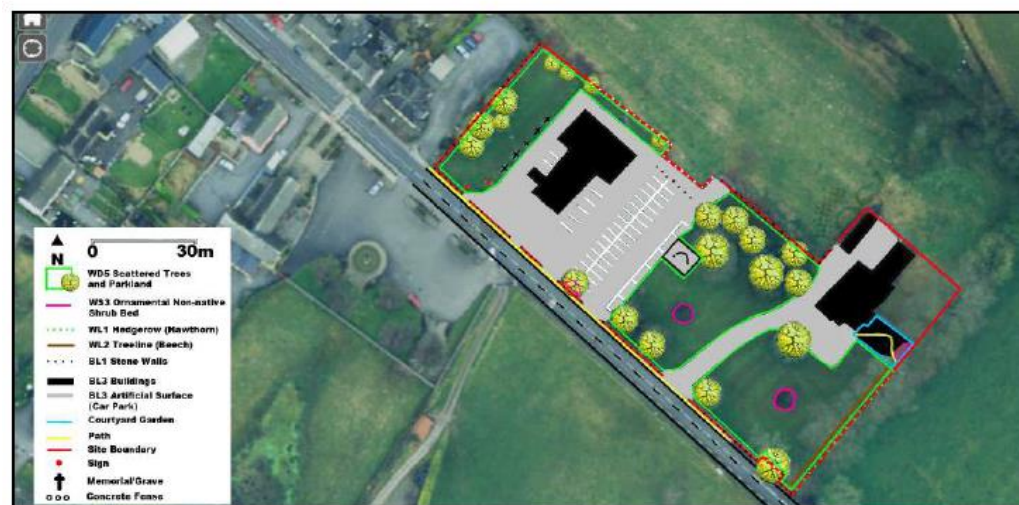
*Illustrations 04 & 05: - (Ref Dr C A O Connell) indicating biodiversity study areas and habitat delineation within Church grounds (2022 – 2026). (Ref: Biodiversity Study for larger illustrations)*

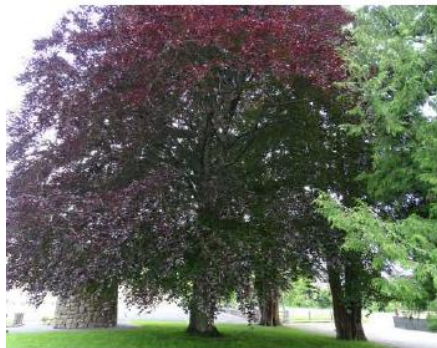
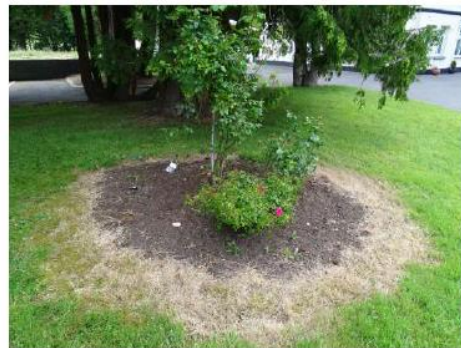
Plate 1 left: Fine specimen of copper beech in the scattered trees and parkland habitat in the grounds of the Church of St Colmcille. Photo: © C. O'Connell. Plate 2 right: Rose bed with evidence of spraying Action 8.1.10 recommends spraying is stopped in the interest of enhancing biodiversity. Photo: © C. O'Connell.

| Action Number | Timescale<br>Short 1-2 years,<br>medium 3 years,<br>long 4-5 years | Action | Notes |
|---|---|---|---|
| 8.1.10 | Short | Stop the use of sprays in the church grounds | There is evidence that sprays are being used in the Church grounds. This practice needs to stop in the interest of health and safety and wildlife enhancement |

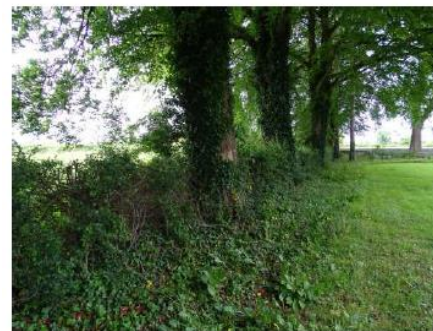
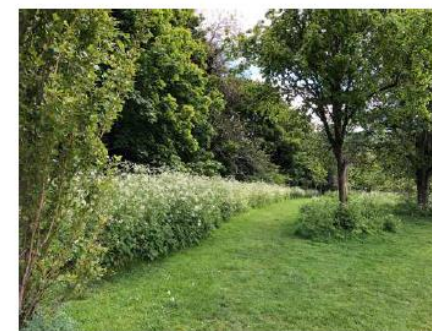
Plate 3: the image on the left shows the hedge and tree line on the south eastern margin of the church grounds. The image on the right shows the development of a herb layer of cow parsley in Bushy Park, Dublin through the absence of mowing in spring (see Action 8.1.4 in Table 4). This action creates wildlife corridor. Photos © C. O'Connell and A. O'Connell

| Action Number | Timescale<br>Short 1-2 years,<br>medium 3 years,<br>long 4-5 years | Action | Notes |
|---|---|---|---|
| 8.1.4 | Short | Create naturally defined corridors for wildlife (see Plate 3) | Provide natural corridors along which insects or animals can pass by allowing a strip of grassland 1-2m wide to grow, flower and set seed along all hedges and under large trees in the parkland habitat. Once a year mow the entire grassland meadow area and remove waste to the compost heap. This helps to control vigorous grass growth. Scarify the ground with rakes to help wild flower seeds make contact with bare soil and germinate to increase the abundance of wild flowers in subsequent years. This action helps to promote biodiversity around the perimeters of species poor habitats such as amenity grassland within the parkland habitat. |

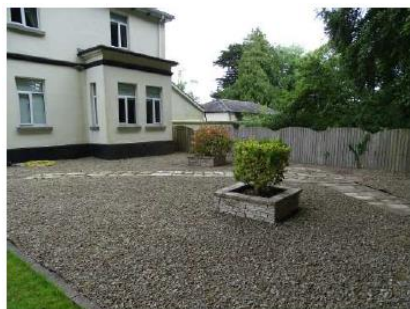
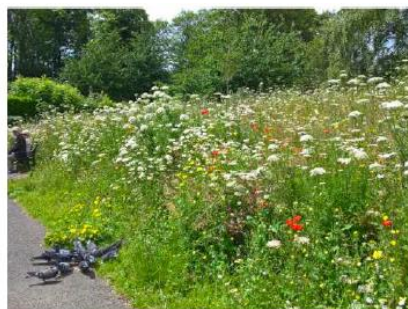
Plate 4: The image on the left shows the gravelled courtyard garden adjacent to the parochial house with a paved path. The image on the right shows a wildflower meadow pollinator friendly garden developed in Herbert Park Dublin. Action 8.1.6 in Table 4 proposes this biodiversity enhancement for the courtyard garden. This kind of management in the enhances biodiversity and creates a spring/summer display of wild flowers to the delight of those using the Church for prayer and special occasions. Photos © C. O'Connell & A. O'Connell

| Action Number | Timescale<br>Short 1-2 years,<br>medium 3 years,<br>long 4-5 years | Action | Notes |
|---|---|---|---|
| 8.1.6 | Medium | Redesign courtyard garden as a pollinator friendly wild flower meadow (see Plate 4) | A new design should be provided for the courtyard garden next to the parochial house. This should be pollinator friendly. The hard surface material needs to be lifted to expose the soil beneath. This soil may be poor and ideally suited to the development of a wildflower meadow developed from a seed mix. |

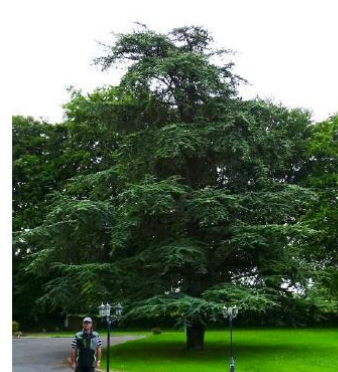
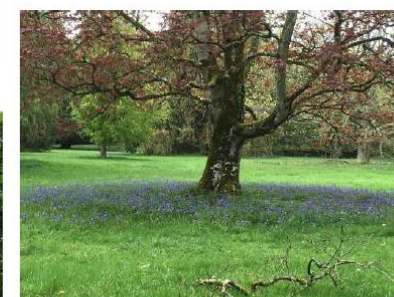
Plate 5: The image on the left shows the cedar of Lebanon tree in the St Colmcille's church grounds. The image on the right shows a beech specimen tree in Emo Gardens Co. Laois where native bluebells (*Hyacinthoides non-scripta*) have been naturalised under the tree. For many people the emergence of bluebells is a sign that spring has sprung. Action 8.1.7 in Table 4 proposes this biodiversity enhancement for large trees in St Colmcille's Church in Ballinahown. Photos © C. O'Connell

| Action Number | Timescale<br>Short 1-2 years,<br>medium 3 years,<br>long 4-5 years | Action | Notes |
|---|---|---|---|
| 8.1.7 | Medium | Create a woodland wildlife garden under the specimen trees e.g. Cedar of Lebanon and Copper Beech (see Plate 5) | The specimen trees are a focal point in the Church grounds. The shaded conditions under these trees where grass does not grow are ideal for woodland plants such as snowdrop, cow parsley, lesser celandine, wood anemone, primrose, bluebell, lords and ladies, ramson and native ferns. |

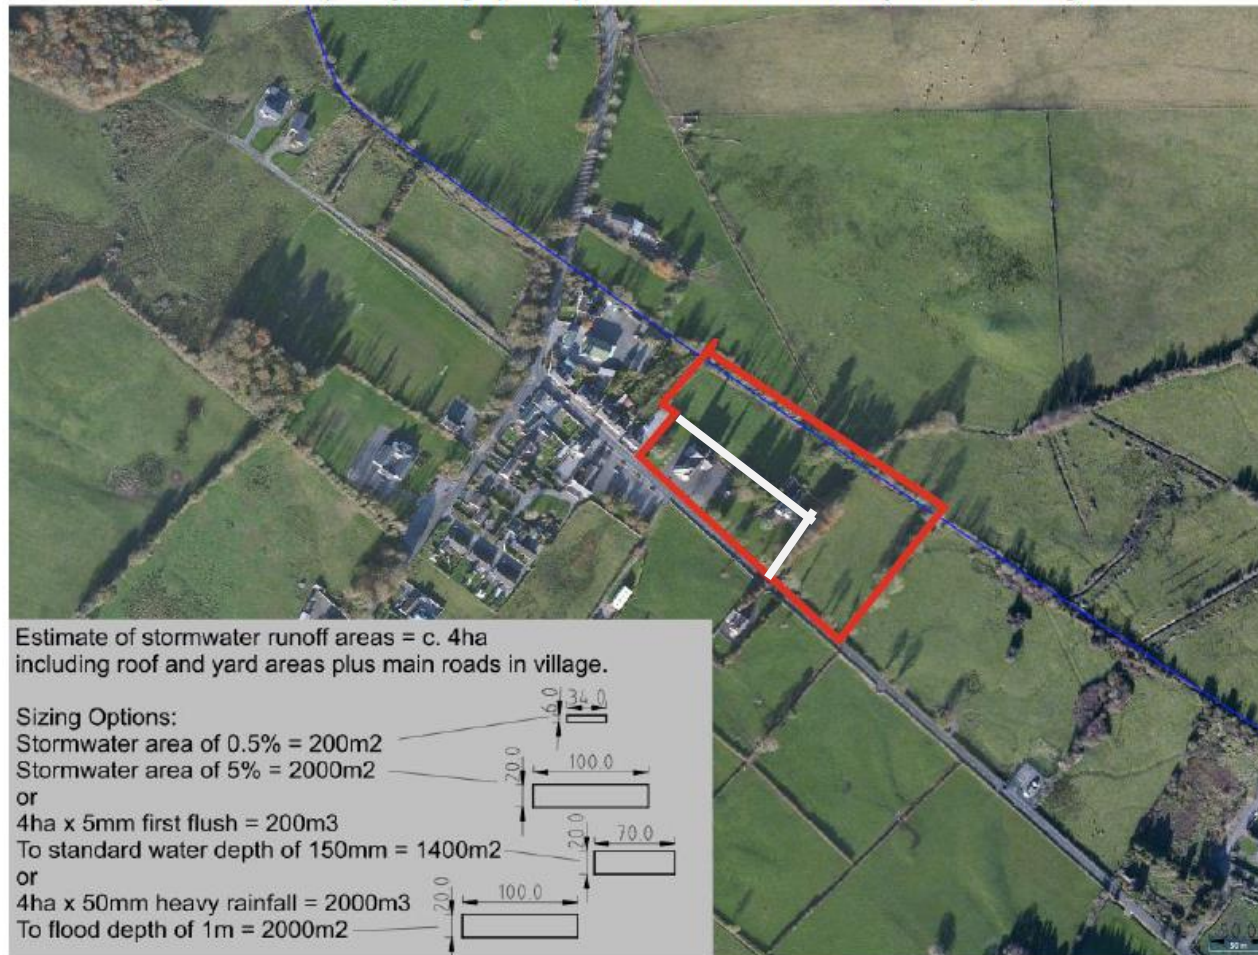
Fig. 10.1 – Examples of sizing options for a stormwater wetland for the full village

*Illustration 11:* Biobased Surface Water Drainage Area calculations:- The red enclosed area is the overall study area for this plan, while the white line differentiates the active Church grounds to the front from the drainage area to the rear.

5.4 **Bio-based Drainage:** - The rear of the site which drains down to the river Worm has been reviewed for the purposes of creating an Ecological Surface Water Management Plan for the village under the auspices of the Local Authorities Waters Programme (LAWPRO) and designed by FH Wetland Systems Ltd. Any future plans for the Church and grounds will necessitate consultation with Féidhlim Harty, of FH Wetland Systems Ltd, the author of the Water Management Plan, the layout of which is indicated within the site plan above. The strategy plan also indicates an existing septic tank located adjacent to the shrine within the Church grounds, and which is in need of significant medium-term attention. Investigations completed by *Independent Drain Testing Ltd*, indicate that the tank is susceptible to ground water infiltration, has no differentiated percolation area and drainage pipes have back-flows and leakage. A biobased drainage solution is recommended as part of this report.

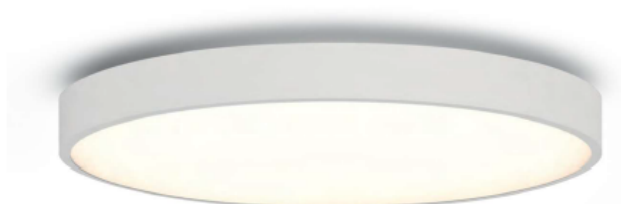
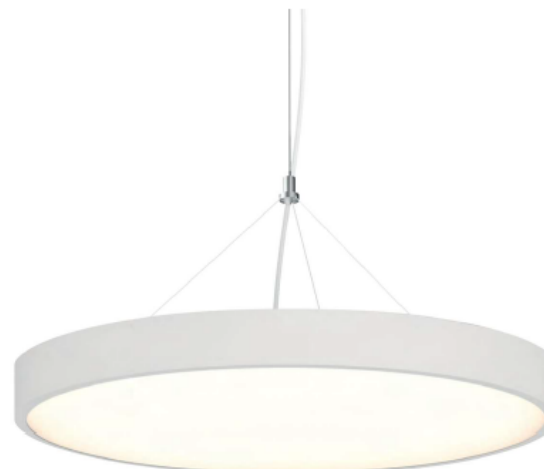
## Sky Surface / Sky Recessed / Sky Pendant

**Body**  
Aluminium body with electrostatic  
100% polyester paint finish.

**Diffuser**  
Frosted acrylic diffuser with  
perfect light uniformity.

**Light Source**  
LED modules with  
excellent colour consistency  
(3 step-MacAdam) and long  
operating lifespan (>50,000h;  
L80/B10). LED CRI >80 3000K,  
4000K.

7.3 (cont.) Sample of suspended light fittings for potential use within church, (reusing existing connections)
